# Army Lodging Wellness Recommendation

Fort Carson

August 12, 2003

**3D/I**

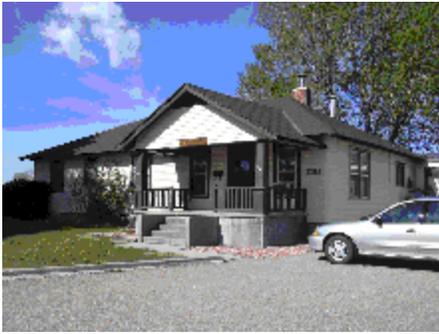
*Building 1919  
1919 Specker  
Fort Carson, Colorado*

Because the Renovation to Replacement Cost Ratio is greater than 50%, renovation of Building 1919 is not recommended.

Soft goods: 3 mattresses and box springs, 3 bedspreads, curtains and rods, 10 lamps, linens for two bathrooms and 18 pictures. All in poor condition..

- Analysis: Exterior windows are aluminum and in poor condition.

- Analysis: Exterior doors are wood in wood frames in fair to poor condition.

- Analysis: Interior wall finishes are painted gypsum board in fair to poor condition.
- Recommendation: Replacement is recommended.

- Analysis: Floor finishes are carpet and sheet vinyl and are in fair to poor condition.
- Recommendation: Replacement is recommended.

- Analysis: Ceiling finishes are painted gypsum board in fair to poor condition.
- Recommendation: Replacement is recommended.

- Analysis: Cooling is provided by window units in poor condition.

- Analysis: There are no fire sprinklers in this building.
- Recommendation: Install sprinkler system as required by code.

- Analysis: The main electrical service is a 125 amp, 120/240 volt, single phase, 3 wire, 24 spaces panel in poor condition.
- Recommendation: Replacement is recommended.

- Recommendation: Replacement is recommended.

- Recommendation: Replacement of window unit air conditioners is recommended.

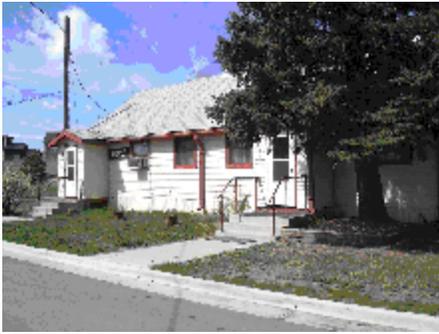
*Building 6215  
6215 Mekong Street  
Fort Carson, Colorado*

Building T-6215, the Scrub Oak Lodge, constructed in the 1940's, contains 3 suites. This facility currently exceeds Army Lodging size requirements. Converting Scrub Oak Lodge to meet the current standards will require significant construction and will exceed the 50% replacement cost.

Our recommendation is to remove building T-6215 from the Lodging inventory, allowing the installation to determine an alternate use for the facility. Scrub Oak Lodge will be removed from the Fort Carson Wellness Solution and Lodging Master Plan.

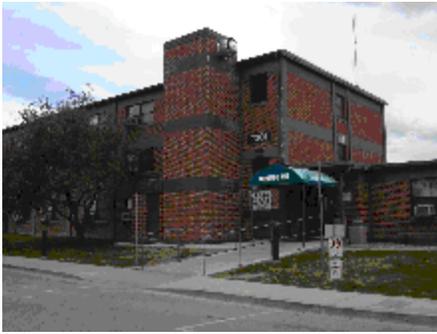
Building 7301  
7301 Woodfill Road  
Fort Carson, Colorado

Building 7301, The Colorado Inn, constructed in 1970, currently serves as the primary Lodging facility for Fort Carson. In addition to 18 standard rooms, Lodging administrative offices, and back-of-house functions, the Colorado Inn also contains offices for Installation Housing staff. The rooms in this building are approximately 250 square feet. Converting these rooms to current Army Lodging standards will exceed the 50% replacement cost.

Our recommendation is to remove building 7301 from the Lodging inventory, allowing the installation to determine an alternate use for the facility. Administrative and back-of-house functions will be relocated into the new proposed facility. The Colorado Inn will be removed from the Fort Carson Wellness Solution and Lodging Master Plan.

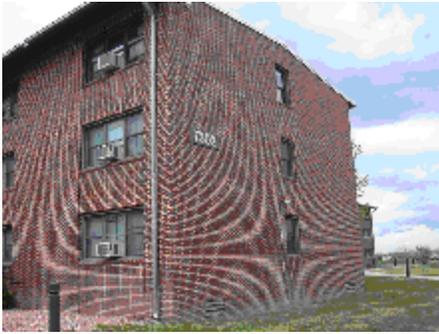
*Building 7302  
7302 St. Lo Drive  
Fort Carson, Colorado*

Buildings 7302 and 7304, constructed in 1970, both contain 78 extended stay rooms. Converting these rooms to meet demand requirements and Army Lodging standards will exceed the 50% replacement costs.

Our recommendation is to remove buildings 7302 and 7304 from the Lodging inventory, allowing the installation to determine an alternate use for these facilities. These buildings will be removed from the Fort Carson Wellness Solution and Lodging Master Plan.

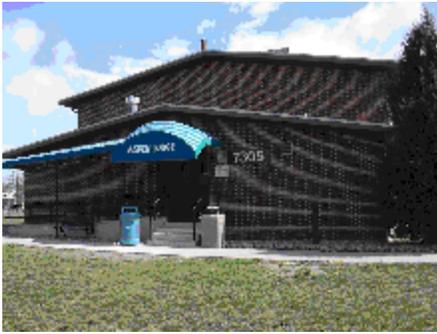
*Building 7305  
7305 St. Lo Drive  
Fort Carson, Colorado*

Building 7305, Aspen Lodge, constructed in 1970, currently houses 8 DVQ suites. Four of these are 1-bedroom suites and four are 2-bedroom suites. As indicated in the Facility Assessment, the building's structure and systems are in fair condition; however, converting these rooms to current Army Lodging standards will exceed the 50% replacement cost.

Our recommendation is to remove building 7305 from the Lodging inventory, allowing the installation to determine an alternate use for the facility. Aspen Lodge will be removed from the Fort Carson Wellness Solution and Lodging Master Plan.
