Army Lodging Wellness Recommendation

Fort Leavenworth - Final Submittal

July 25, 2003

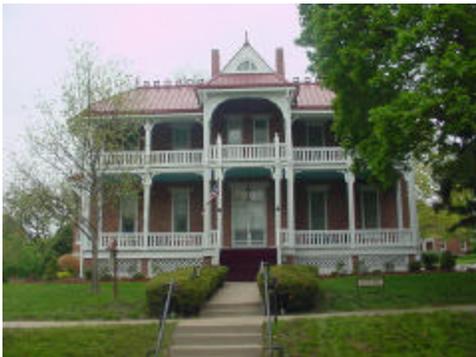
Building 3, Custer House

Building 3, constructed in 1883, is a historical structure and is divided into 6 DVQ rooms. This facility has two stories plus a basement. Each room ranges from 220 to 804 square feet. The building is in good condition but does not comply with Lodging requirements. The cost to make improvements and bring it up to Army Lodging standards will exceed the 50% replacement cost.

Our recommendation is to remove building 3 from the Lodging inventory, allowing the installation to determine an alternate use for this facility. This facility will be removed from the Fort Leavenworth Wellness Solution and Lodging Master Plan.

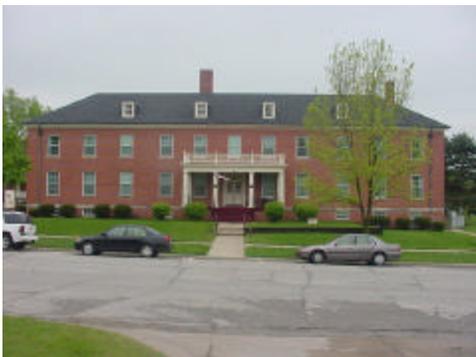
Building 22, Cooke Hall

Building 22, constructed in 1934, is a historical structure and is divided into 9 DVQ rooms. This facility has two stories plus a basement. Each suite/room ranges from 328 to 504 square feet each. This building was renovated in 1986 and had its roof replaced in 2002. The building is in fair condition but does not comply with Lodging requirements. The cost to make improvements and bring it up to Army Lodging standards will exceed the 50% replacement cost.

Our recommendation is to remove this building from the Lodging inventory, allowing the installation to determine an alternate use for this facility. This facility will be removed from the Fort Leavenworth Wellness Solution and Lodging Master Plan.

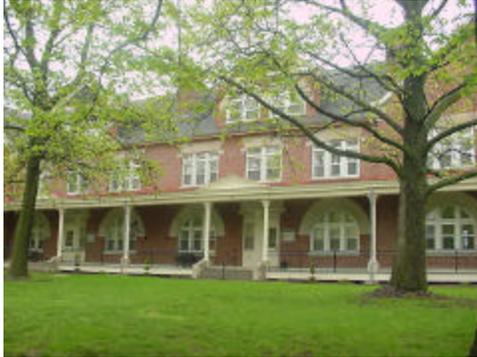
Building 43, Schofield Hall

Building 43, constructed in 1892, is a historic structure that is divided into 23 suites. This facility has three stories plus a basement. Each suite has 597 square feet, consisting of a living room, bedroom, and full bath. In 1989, the windows were replaced, the electrical system upgraded, and the structure reinforced. The building is in fair condition but does not comply with Lodging standards. The cost to make improvements and bring it up to Army Lodging standards will exceed the 50% replacement cost.

Our recommendation is to remove this building from the Lodging inventory, allowing the installation to determine an alternate use for this facility. This facility will be removed from the Fort Leavenworth Wellness Solution and Lodging master plan.

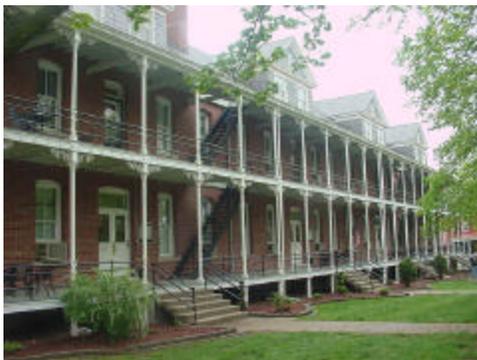
Building 197, Root Hall

Building 197, constructed in 1901, is a historic structure that has 15 family suites. The facility is a three story building plus basement, with rooms consisting of 504 square feet, each with a living room, bedroom, and full bath. In 1989, the electrical system was upgraded, and the plumbing was renovated throughout the facility. The building is in fair condition but does not comply with Lodging standards. The cost to make improvements and bring it up to Army Lodging standards will exceed the 50% replacement cost.

Our recommendation is to remove this building from the Lodging inventory, allowing the installation to determine an alternate use for this facility. This facility will be removed from the Fort Leavenworth Wellness Solution and Lodging master plan.

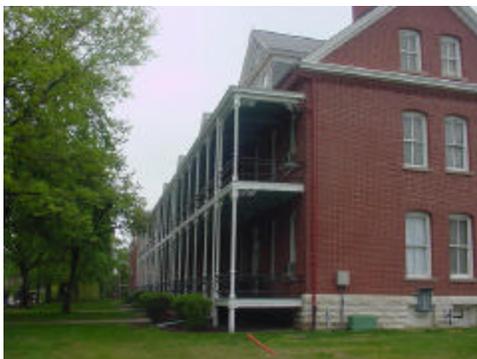
Building 213, Otis Hall

Building 213, constructed in 1903, is a historic structure that has 8 family suites at 615 square feet and 8 DVQ rooms at 1,142 square feet. The facility is three stories plus a basement. Each DVQ has a living room, bedroom, kitchen, and full bath. In 1987, a complete renovation was accomplished, with the exception of the addition of central air conditioning. The building is in fair condition but does not comply with

Lodging standards. The cost to make improvements and bring it up to Army Lodging standards will exceed the 50% replacement cost.

Our recommendation is to remove this building from the Lodging inventory, allowing the installation to determine an alternate use for this facility. This facility will be removed from the Fort Leavenworth Wellness Solution and Lodging master plan.

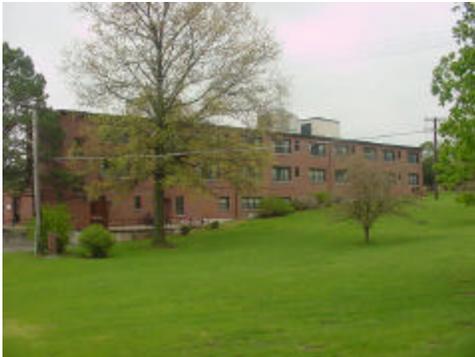
Building 225, Truesdell Hall

Building 225, constructed in 1959, is divided into 44 suites. This facility has two stories plus a basement. Each suite has 544 square feet, consisting of a living room, bedroom, and bath (with shower not tub). The building is in fair condition but does not comply with Lodging standards. **The cost to make condition assessment improvements will exceed the 50% replacement cost.**

Our recommendation is to remove this building from the Lodging inventory, allowing the installation to determine an alternate use for this facility. This facility will be removed from the Fort Leavenworth Wellness Solution and Lodging master plan.

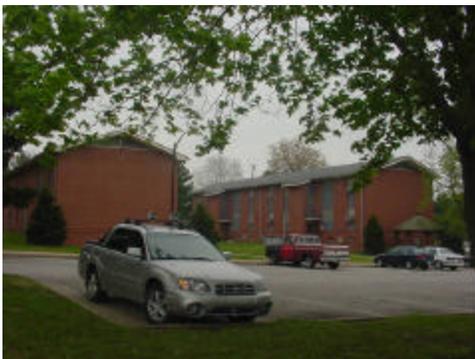
Buildings 338 and 339, Blochberger Terrace

Building 338, constructed in 1963, has 16 single rooms. This facility has two stories plus a basement. Each room has 315 square feet. In 2003 central air conditioning was installed. Building 339, constructed in 1963, has 16 extended stay rooms, and 3 two-room suites in the basement. This facility has two stories plus a basement. Each extended stay room has 340 square feet. In 2003 central air conditioning was installed. These buildings are in good condition but do not comply with Lodging standards. **The cost to make condition assessment improvements will exceed the 50% replacement cost.**

Our recommendation is to remove these buildings from the Lodging inventory, allowing the installation to determine an alternate use for this facility. These facilities will be removed from the Fort Leavenworth Wellness Solution and Lodging master plan.

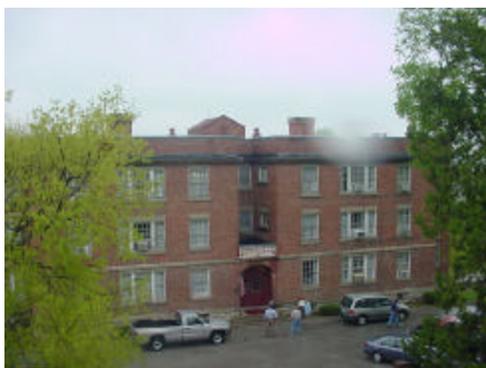
Building 427, Riverside Apartments

Building 427, constructed in 1921, has 12 multi-room suites. This facility has three stories plus a basement. Each suite has 503 square feet, consisting of a living room, bedroom, kitchen, and full bath. Each guest room has 316 square feet. The building is in poor condition and does not

comply with Lodging standards. **The cost to make condition assessment improvements will exceed the 50% replacement cost.**

Our recommendation is to remove this building from the Lodging inventory, allowing the installation to determine an alternate use for this facility. This facility will be removed from the Fort Leavenworth Wellness Solution and Lodging master plan.

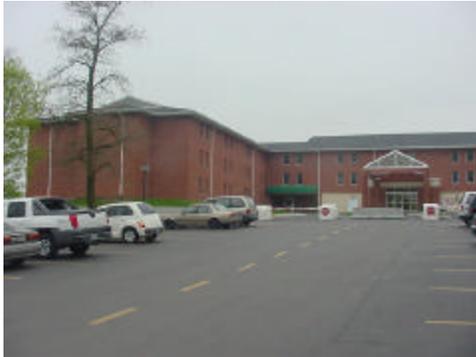
Lodging Building 695, Hoge Barracks

Building 695, constructed in 1987, has 614 rooms. This facility has three stories, with a basement in building “D”. The rooms are approximately 300 square feet each, with two rooms sharing a full kitchen and bath. Building 695 is used as the main Lodging facility and has most of the back-of-the-house and public spaces required. The building is in excellent condition but does not comply with the Lodging standards.

Our recommendation is to renovate this facility to bring it up to current Army Lodging standards, as part of the Fort Leavenworth Wellness Solution and Lodging Master Plan.

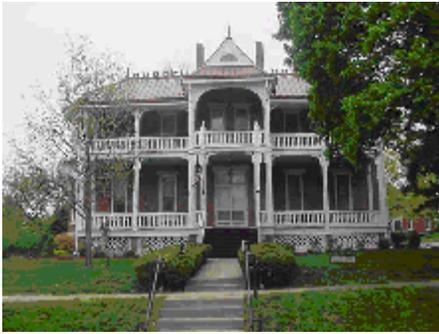
*Building 3
220 Pope
Ft. Leavenworth, KS*

Because the Renovation to Replacement Cost Ratio is greater than 50%, renovation of Building 3 is not recommended.

- Analysis: The foundation is of limestone on compacted soil. No clear failures can be seen from perimeter. The foundation is in good condition.
- Recommendation: No corrective action required.

- Analysis: The painted plaster on lath walls are in fair condition.
- Recommendation: Install vinyl wallcovering.

- Analysis: The waste system was replaced in 1986. A floor drain is needed in the laundry. The overall plumbing system is in good condition.
- Recommendation: Install new floor drains in the laundry room.

- Analysis: The electrical system is in fair condition. Interior wiring, plugs and receptacles are approaching the end of their life-cycle and the panel is undersized. Site lighting is inadequate.
- Recommendation: The 200 A panel should be upgraded to a 400 A panel. All interior wiring, plugs and receptacles should be replaced. At least one (1) pole and light fixture should be added to improve site lighting.
