# Army Lodging Wellness Recommendation

## Fort Meade - Final Submittal

July 25, 2003

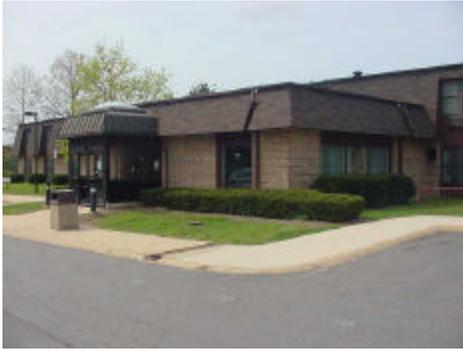
### ***Lodging Building 2793***

Building 2793, constructed in 1972, is a two story facility housing 54 extended stay rooms. While this facility currently meets the Army Lodging size standards it is **poor** condition. The building is a wood frame construction with only a 40-50 year life cycle. Because of the age in 2008 it is our recommendation that further money not be spent to enhance this facility. **The cost to make condition assessment improvements will exceed 50% replacement cost.**

Our recommendation is to remove building 2793 from the Lodging inventory, allowing the installation to determine an alternate use for this facility. This facility will be removed from the Fort Meade Wellness Solution and Lodging master plan.

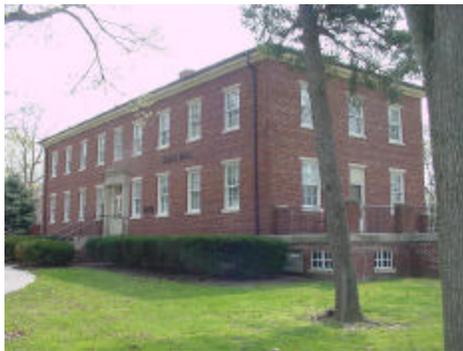
### ***Lodging Building 4415***

Building 4415, Kuhn Hall, constructed in 1944, is a two-story facility housing seven DVQ suites. **The was in poor condition.**  
**The cost to make condition assessment improvements will exceed 50% replacement cost.**

Our recommendation is to remove building 4715 from the Lodging inventory, allowing the installation to determine an alternate use for this facility. This facility will be removed from the Fort Meade Wellness Solution and Lodging master plan.

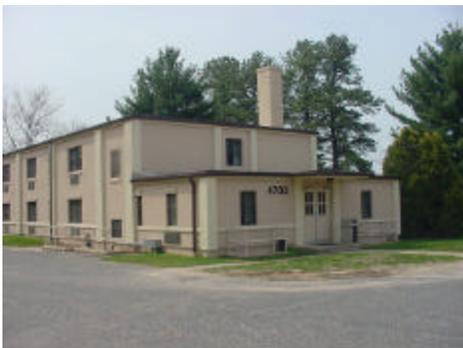
### ***Lodging Building 4703***

Building 4703, Norton Hall, constructed in the late 1930's is a two-story facility housing 14 two-bedroom guest rooms with shared bath rooms, and two one-bedroom guest rooms with shared bath rooms. This facility is in **poor** condition, but does not meet current Army Lodging standards. **The cost to make condition assessment improvements will exceed 50% replacement cost.**

Our recommendation is to remove building 4703 from the Lodging inventory, allowing the installation to determine an alternate use for this facility. This facility will be removed from the Fort Meade Wellness Solution and Lodging master plan.

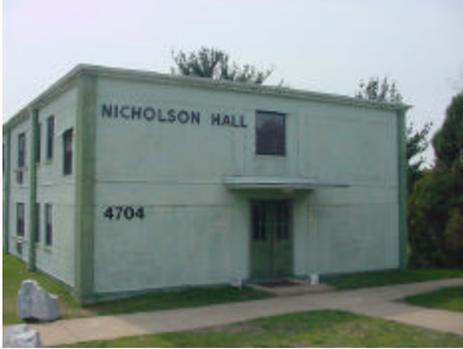
### ***Lodging Building 4704***

Building 4704, Nicholson Hall, constructed in the late 1930's is a two-story facility housing 30 one-bedroom guest rooms with shared bath rooms. This facility is in **poor** condition, but does not meet current Army Lodging standards. **The cost to make condition assessment improvements will exceed 50% replacement cost.**

Our recommendation is to remove building 4704 from the Lodging inventory, allowing the installation to determine an alternate use for this facility. This facility will be removed from the Fort Meade Wellness Solution and Lodging master plan.

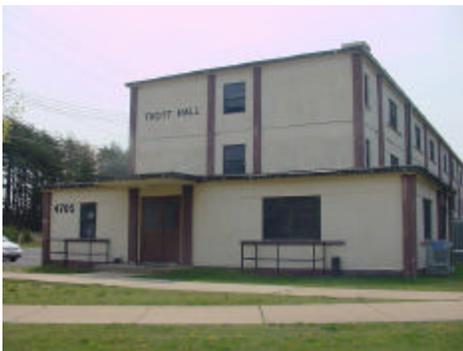
### ***Lodging Building 4705.***

Building 4705, Trott Hall, constructed in the early 1930s, is a three-story facility housing 30 two-bedroom guest rooms with shared bath rooms, and two one-bedroom guest rooms with shared bath rooms. This facility is in **poor** condition, but does not meet current Army Lodging standards. **The cost to make condition assessment improvements will exceed 50% replacement cost.**

Our recommendation is to remove building 4705 from the Lodging inventory, allowing the installation to determine an alternate use for this facility. This facility will be removed from the Fort Meade Wellness Solution and Lodging master plan.

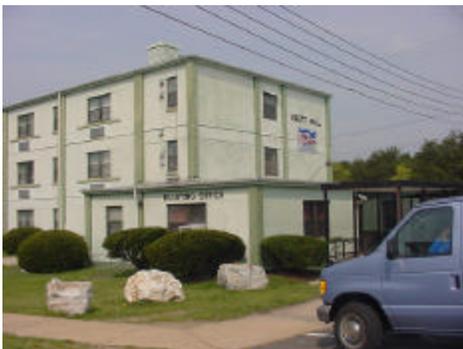
### ***Lodging Building 4707***

Building 4707, Brett Hall, constructed in the late 1930s, is the Lodging office for the installation. This three-story facility houses 56 one-bedroom guest rooms with shared bath rooms, is in **poor** condition, but does not meet current Army Lodging standards. **The cost to make condition assessment improvements will exceed 50% replacement cost.**

Our recommendation is to remove building 4707 from the Lodging inventory, allowing the installation to determine an alternate use for this facility. This facility will be removed from the Fort Meade Wellness Solution and Lodging master plan.

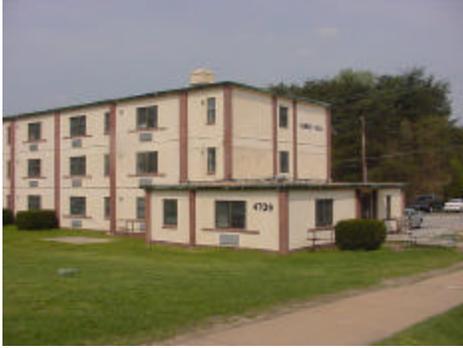
### ***Lodging Building 4709.***

Building 4709, Heard Hall, constructed in the late 1930s, is a three-story facility housing 59 one-bedroom guest rooms with shared baths rooms. This facility is in **poor** condition, but does not meet current Army Lodging standards. **The cost to make condition assessment improvements will exceed 50% replacement cost.**

Our recommendation is to remove building 4709 from the Lodging inventory, allowing the installation to determine an alternate use for this facility. This facility will be removed from the Fort Meade Wellness Solution and Lodging master plan.

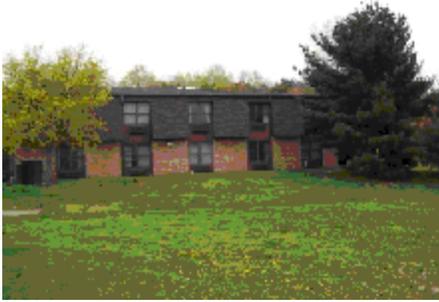
Building 2793  
2793 Hawkins Drive

Building 2793 was constructed in 1972 . The 24,700 square foot facility contains 54 extended stay rooms . The building is functioning as standard stay rooms for personnel in PCS transition.

Because the Condition Assessment to Replacement Cost Ratio is greater than 50%, renovation of Building 2793 is not recommended.
