# Army Lodging Wellness Recommendation

Fort Sill - Final Submittal

August 18, 2003

**3D/I**

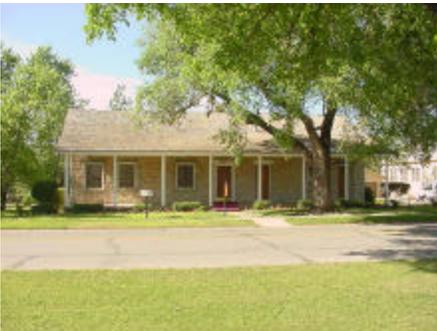
### ***Lodging Building 343 “Wichita House”***

Building 343, constructed in 1870, is a single story historical structure, without a basement, serving as a 3-bedroom DVQ suite. The building is in fair condition but does not meet current Army Lodging standards. The cost to make improvements and to bring this facility up to Army Lodging standards will exceed the 50% replacement cost.

Our recommendation is to remove building 343 from the Lodging inventory, allowing the installation to determine an alternate use for the facility. This facility will be removed from the Fort Sill Wellness Solution and Lodging Master Plan.

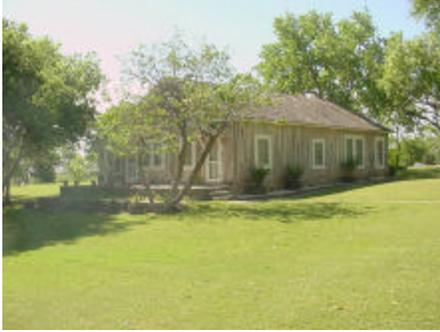
### ***Lodging Building 380 “Pickett House”***

Building 380, constructed in 1870, is a single story historic structure, without a basement, serving as a 2-bedroom DVQ suite. This facility received an interior renovation in 1992. The building is in fair condition but does not meet current Army Lodging standards. The cost to make improvements and to bring this facility up to Army Lodging standards will exceed the 50% replacement cost.

Our recommendation is to remove building 380 from the Lodging inventory, allowing the installation to determine an alternate use for the facility. This facility will be removed from the Fort Sill Wellness Solution and Lodging Master Plan.

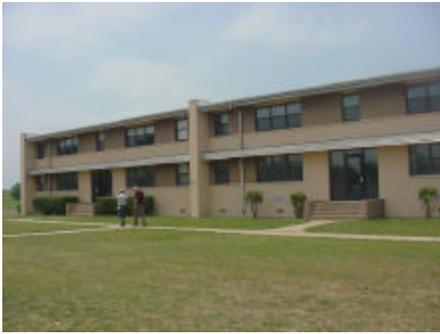
### ***Lodging Buildings 5670, 5671, 5672, 5673, 5674, 5675***

Buildings 5670, 5671, 5672, 5673, 5674, and 5675, are 2-story structures, similar in construction and age. Buildings 5670, 5671, 5674 and 5675, constructed in 1963, each house 16 family suites at 688 square feet each. Buildings 5672 and 5673, constructed in 1963, each house 14 family suites at 688 square feet each. These buildings are in fair condition, but do not meet current Army Lodging standards. The cost to make improvements and to bring this facility up to Army Lodging standards will exceed the 50% replacement cost.

Our recommendation is to remove these buildings from the Lodging inventory, allowing the installation to determine alternate uses for these facilities. These facilities will be removed from the Fort Sill Wellness Solution and Lodging Master Plan.

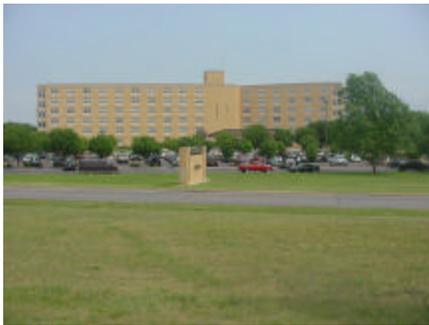
### ***Lodging Building 5676 Aultman Hall***

Building 5676, constructed in 1966, houses 120 standard rooms at 288 square feet, 110 extended stay rooms at 288 square feet, and 7 DVQ rooms at 440 square feet each. This facility is a 6-story structure without a basement and serves as the main Lodging facility for the installation. The building is in fair condition and will require minor renovation to bring the facility up to current Army Lodging standards. This facility incorporates most of the Army Lodging standards for the public and back-of-the-house spaces. It is our recommendation to continue use as it is currently functioning. The cost to make recommended improvements will not exceed the 50% replacement cost.

Our recommendation is building 5676 remain in the Lodging inventory and continue to serve as the main Lodging facility as part of the Fort Sill Wellness Solution and Lodging Master Plan.

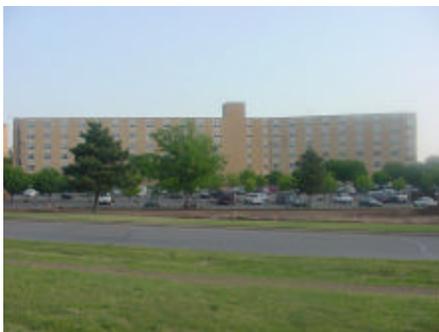
### ***Lodging Building 5678 Allin Hall***

Building 5678, constructed in 1967, houses 287 standard rooms at 288 square feet and 2 DVQ rooms at 440 square feet each. This facility is a 6-story structure without a basement. The building is in good condition, and the room configurations meet current Army Lodging standards. The cost to make improvements and to bring this facility up to Army Lodging standards will not exceed the 50% replacement cost.

Our recommendation is that building 5678 remain in the Lodging inventory and continue to serve as part of the Fort Sill Wellness Solution and Lodging Master Plan.

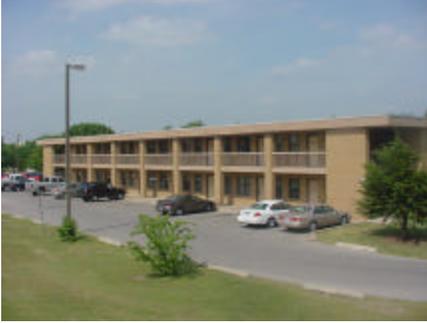
### ***Lodging Buildings 5691, 5692, 5693 “Geronimo Lodge”***

Buildings 5691, 5692, and 5693, constructed in 1988, are 2-story structures without basements, and are similar in construction and age. Access to the rooms is from the exterior, either from grade or from a balcony. Building 5691 houses 19 family suites at 340 square feet each. Building 5692 houses 24 family suites at 340 square feet each. Building 5693 houses 32 family suites at 340 square feet each. These buildings are in fair condition, but do not meet current Army Lodging standards. The cost to make improvements and to bring this facility up to Army Lodging standards will exceed the 50% replacement cost.

Our recommendation is to remove these buildings from the Lodging inventory, allowing the installation to determine alternate uses for these facilities. These facilities will be removed from the Fort Sill Wellness Solution and Lodging Master Plan.

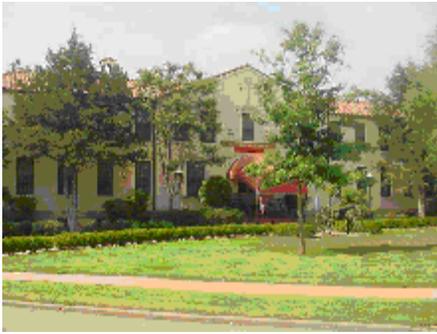
*Building 460, Comanche House,  
Hamilton Road, Ft. Sill, OK*

Building 460, constructed in 1934, is a 2-story historic structure with basement, housing 6 DVQ rooms without a kitchen at 338 square feet, 5 DVQ rooms without a kitchen at 312 square feet, 1 DVQ room without a kitchen at 156 square feet, and 1 DVQ room without a kitchen at 850 square feet. The building is in poor condition and does not meet current Army Lodging standards. The cost to make condition assessment improvements will exceed the 50% replacement cost.

Our recommendation is to remove building 460 from the Lodging inventory, allowing the installation to determine an alternate use for the facility. This facility will be removed from the Fort Sill Wellness Solution and Lodging Master Plan.

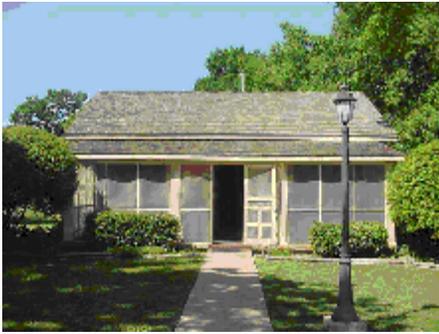
*Building 5715, Little House on the Prairie, Gruber Road, Ft. Sill, OK*

Building 5715, constructed in 1940, is a 1,279 square foot single story historical structure, without a basement, serving as a single DVQ room. The building is in fair condition but does not meet current Army Lodging standards. The cost to make improvements and to bring this facility up to Army Lodging standards will exceed the 50% replacement cost.

Our recommendation is to remove building 5715 from the Lodging inventory, allowing the installation to determine an alternate use for the facility. This facility will be removed from the Fort Sill Wellness Solution and Lodging Master Plan.
