Army Lodging Wellness Recommendation

Fort Tripler/Shafter - Final Submittal

August 22, 2003

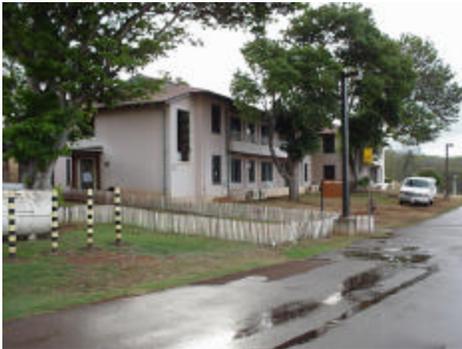
Building 222C, constructed in 1946 as nurse quarters, is a 2-story historical structure housing 24 multi-room suites. Although this facility was renovated, it does not meet Lodging standards and cannot be reconfigured without significant reconstruction. To make condition assessment improvements to Building 222C will exceed the 50% replacement cost.

Our recommendation is to remove building 222C from the Lodging inventory, allowing the installation to determine an alternate use for this facility. This facility will be removed from the Fort Tripler/Shafter Wellness Solution and Lodging Master Plan.

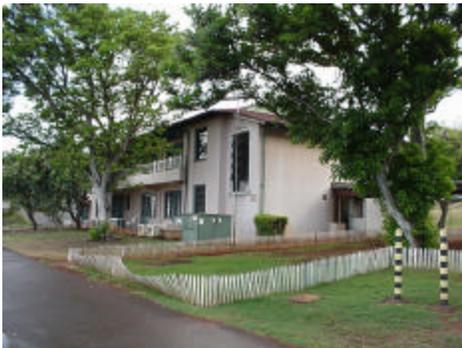
Building 226E, constructed in 1946 as nurse quarters, is a 2-story historic structure housing 15 multi-room suites. Although this facility was renovated, it does not meet Lodging standards and cannot be reconfigured without significant reconstruction. To make condition assessment improvements to Building 226E will exceed the 50% replacement cost.

Our recommendation is to remove building 226E from the Lodging inventory, allowing the installation to determine an alternate use for this

facility. This facility will be removed from the Fort Tripler/Shafter Wellness Solution and Lodging Master Plan.

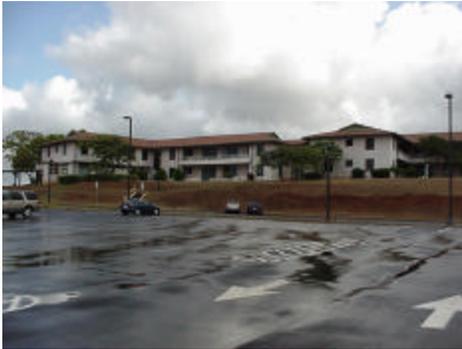
Building 228B

Building 228B, constructed in 1946 as nurse quarters, is a 2-story historical structure housing 38 multi-room suites. Although this facility was renovated, it does not meet Lodging standards and cannot be reconfigured without significant reconstruction. To make condition assessment improvements to Building 228C will exceed the 50% replacement cost.

Our recommendation is to remove building 228C from the Lodging inventory, allowing the installation to determine an alternate use for this facility. This facility will be removed from the Fort Tripler/Shafter Wellness Solution and Lodging Master Plan.

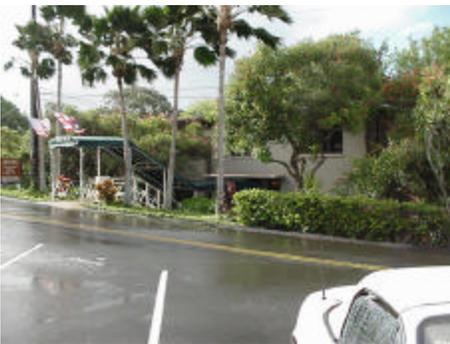
Building 719 (Hale Ali'i)

Building 719, constructed in 1958, is a 2-story structure housing 2 extended stay rooms, 5 family suites. Although this facility was renovated, it does not meet Lodging standards and cannot be reconfigured without significant reconstruction. To make condition assessment improvements to Building 719 will exceed the 50% replacement cost.

Our recommendation is to remove building 719 from the Lodging inventory, allowing the installation to determine an alternate use for this facility. This facility will be removed from the Fort Tripler/Shafter Wellness Solution and Lodging Master Plan.

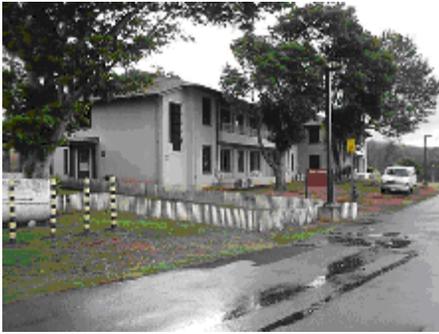
Building 220D was constructed in 1946. The 16,500 square foot facility contains 16 lodging units, operating as 16 family suites.

Condition Assessment Cost	\$2,136,965.00
Replacement Cost	\$2,929,115.00
Condition Assessment to Replacement Cost Ratio	72.96%

Because the Condition Assessment to Replacement Cost Ratio is greater than 50%, renovation of Building 220D is not recommended.

- Analysis: Foundation is of concrete on compacted soil. No clear failures can be seen from the perimeter. Foundation in good condition.
- Recommendation: No corrective action required.

- Analysis: The concrete floor is in good condition, except for cracks in the patio areas.
- Recommendation: No corrective action required for the floor, except repair cracks in patios.

- Analysis: The stucco walls are in good condition, except the paint is beyond expected useful life.
- Recommendation: Repaint walls.

- Analysis: The wooden doors and frames are beyond there expected useful life.
- Recommendation: Replace doors and frames.

- Analysis: The domestic hot water is supplied through copper lines from a central location near building 226. The supply and waste lines are in poor condition.

- Recommendation: Replace supply and waste lines.

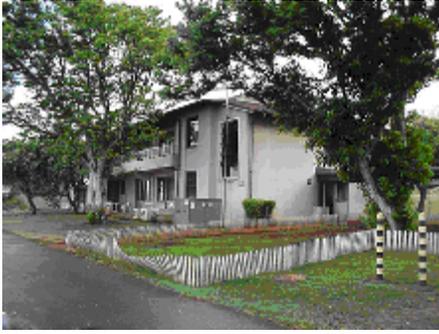
Building 222C was constructed in 1946. The 18,800 square foot facility contains 24 lodging units, operating as 24 family suites.

Condition Assessment Cost	\$3,013,530.00
Replacement Cost	\$3,613,210.00
Condition Assessment to Replacement Cost Ratio	83.40%

Because the Condition Assessment to Replacement Cost Ratio is greater than 50%, renovation of Building 222C is not recommended.

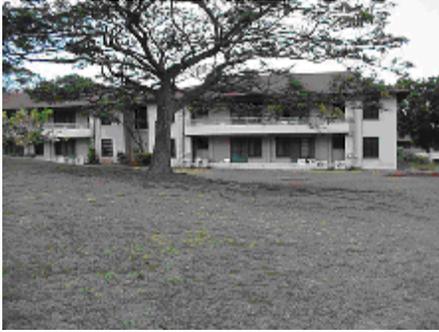
Building 226E was constructed in 1946. The 16,500 square foot facility contains 15 lodging units, operating as 15 family suites.

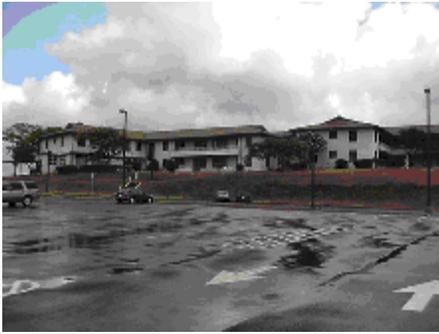
Building 228B was constructed in 1946. The 38,000 square foot facility contains 38 lodging units, operating as 38 family suites.

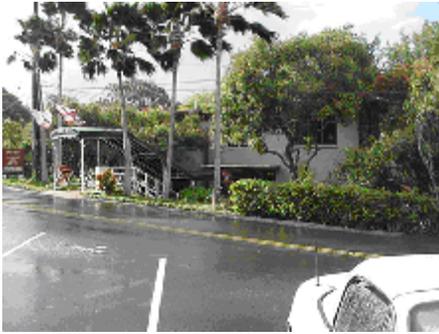
Building 719 was constructed in 1958 and under went limited renovation in 1995. The 7,700 square foot facility contains 7 lodging rooms functioning as 5 family suites and 2 extended stay rooms.
