# Army Lodging Wellness Recommendation

## Aberdeen Proving Ground - Pilot

August 22, 2003

# Aberdeen Proving Ground

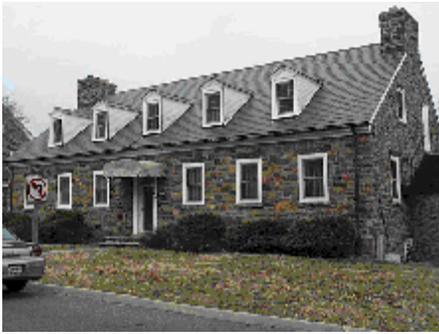
*Building 30 Porter House  
30 Plum Point Loop*

Because the Renovation to Replacement Cost Ratio is greater than 50%, renovation of Building 30 is not recommended.

- Analysis: Foundation is composed of perimeter beam and poured piers on compacted soil. No clear failures can be seen from perimeter. Foundation is in good condition.
- Recommendation: No corrective action required.

- Analysis: The structure is wood frame construction with wood decking for the second floor. The superstructure is in good condition.
- Recommendation: No corrective action required.

- Analysis: Stone masonry walls appear to be in good condition.
- Recommendation: No corrective action required.

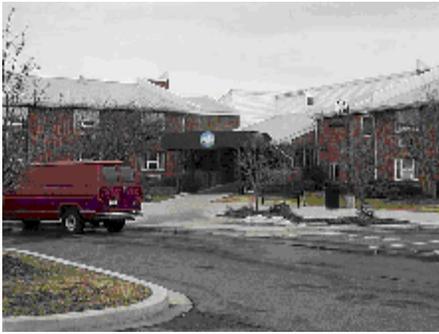
Swan Creek Inn  
2207 Belair Avenue

Building 2207, constructed in 1977, received a major renovation in 1999. The building has 149 existing extended stay rooms. The building is in good condition and meets a majority of the Army functional standards from the perspective of the guest room requirements.

The building infrastructure is to be used over the next 15-20 years with normal maintenance. Based on age of the structure, however, we do not recommend significant renovations to the public spaces and/or back-of-

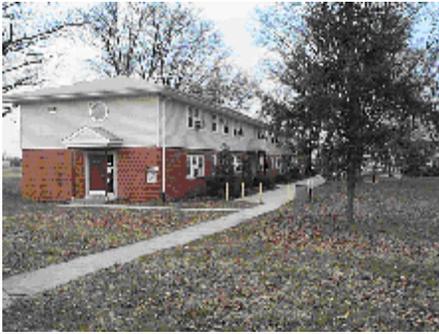
*Building 2208  
2208 Frankford Rd*

These four buildings were built in 1959. Building 2208 has 14 Lodging rooms, building 2209 has 20 Lodging rooms, building 2504 has 16 Lodging rooms, and building 2505 has 20 Lodging rooms. Most rooms are 1-3 bedrooms, with shared kitchens, and some with shared baths. They do not meet current Lodging standards. All four of these buildings are in fair condition, but do not meet Army Lodging standards. The cost to make improvements and bring up to Army Lodging standards will exceed the 50% replacement cost.

Our recommendation is to remove these buildings from the Lodging inventory, allowing the installation to determine an alternate use for the facilities. These facilities will be removed from the Aberdeen Wellness Solution and Lodging Master Plan.

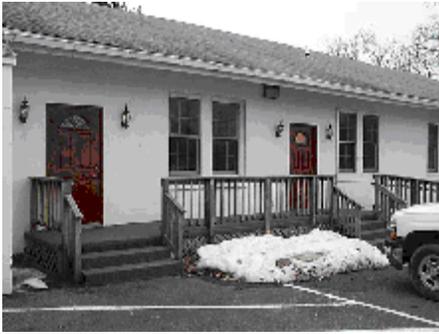
Building E4650  
E4650 Gunpower Loop

This building, constructed in 1992, has two family rooms as part of another structure. It is located in the Edgewood area, approximately 20 minutes from the Aberdeen Proving Ground main installation. Both rooms are two bedrooms with kitchens.

This building and rooms are in good condition as indicated on the Facility Assessment but do not meet the Lodging size requirements or provide appropriate support spaces. The cost to modify to meet Army Lodging standards will exceed the 50% replacement cost.

Our recommendation is to remove building E4950 from the Lodging inventory, allowing the installation to determine an alternate use for the facility. This facility will be removed from the Aberdeen Wellness Solution and Lodging Master Plan.

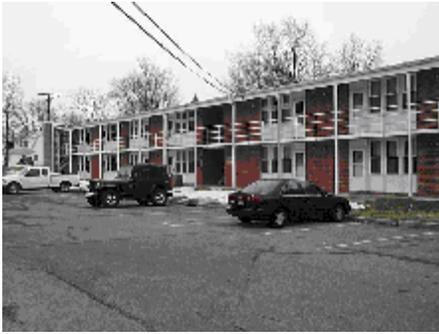
*Building E4900  
E4900 Jessup Ave.*

Both of these buildings are in poor condition, but do meet the Lodging size requirements. The cost to make condition assessment improvements, however, will exceed the 50% replacement cost.

Our recommendation is to remove buildings E4900 and E4902 from the Lodging inventory, allowing the installation to determine an alternate use for the facilities. These facilities will be removed from the Aberdeen Wellness Solution and Lodging Master Plan.
