Army Lodging Wellness Recommendation

Final Submittal - Camp Parks

February 27, 2004

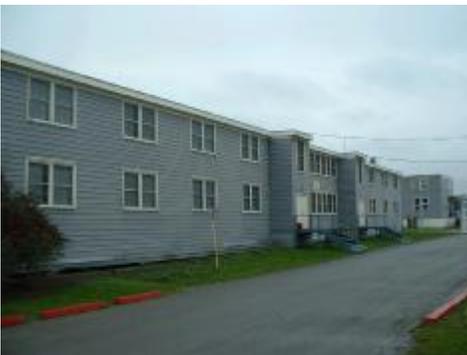
Building 0306

Building 306, a 2-story structure constructed in 1952, houses 26 existing standard guest rooms. This building is an old dormitory building with central bathrooms and is in poor condition. It does not meet size or functional requirements for guest rooms and is missing some of the support spaces to meet Army Lodging Standards. The cost to make improvements and bring this facility up to Army Lodging standards will exceed 50% of the replacement cost.

Our recommendation is to remove building 306 from the Lodging inventory, allowing the installation to determine an alternate use for this facility. This facility will be removed from the Camp Parks Wellness Solution and Lodging Master Plan.

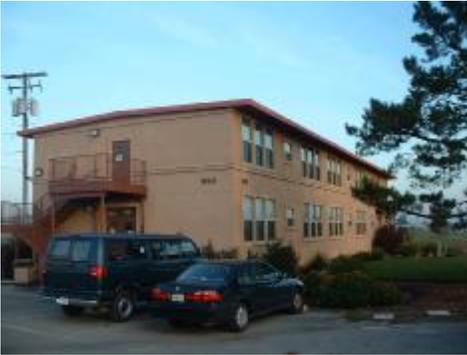
Building 1150, a 2-story structure constructed in 1953, houses 22 existing standard guest rooms. Although renovated in 1999 and in good condition, this building does not meet size requirements for guest rooms and is missing some of support spaces required to meet Army Lodging standards. The building infrastructure is to be used over the next 15-20 years with normal maintenance. Based on the original age of the structure and considering the recent renovation, though, we recommend nominal renovations to the room sizes and minor reconfiguration of support spaces to meet functional criteria. The cost to make improvements and bring these facilities up to Army Lodging Standards will not exceed 50% of the replacement cost. .

Our recommendation is to retain Building 1150 in the Camp Parks Lodging inventory. This facility will remain in the Camp Parks Wellness Solution and Lodging Master Plan.

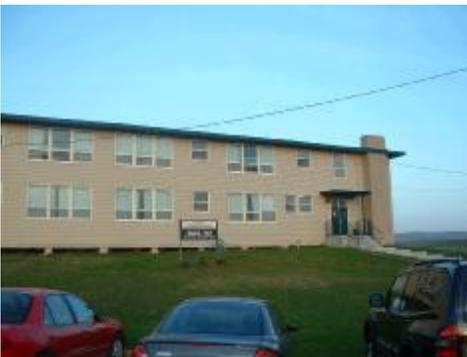
Building 1151, a 2-story structure constructed in 1953, is the main Lodging Facility for the installation and includes 29 existing standard guest rooms and 13 existing family suites. This building is missing the majority of support spaces required for a main Lodging facility, and although renovated within the last 5 years, does not meet Lodging standards and cannot be reconfigured without significant reconstruction. To renovate Building 1151 to the new standards and configuration will exceed 50% of the replacement cost.

Our recommendation is to remove building 1151 from the Lodging inventory, allowing the installation to determine an alternate use for this facility. This facility will be removed from the Camp Parks Wellness Solution and Lodging Master Plan.

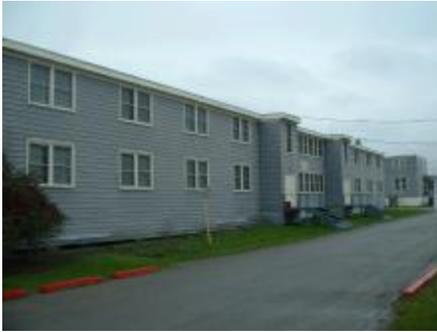
*Building 306
Cromwell Avenue at 8th Street
Parks RFTA
Dublin, California*

Building 306, a 2-story structure constructed in 1952, houses 26 existing standard guest rooms. This building is an old dormitory building with central bathrooms and is in poor condition. It does not meet size or functional requirements for guest rooms and is missing some of the support spaces to meet Army Lodging Standards. The cost to make improvements and bring this facility up to Army Lodging standards will exceed 50% of the replacement cost.

Because the Condition Assessment to Replacement Cost Ratio is greater than 50.00%, repair of Building 0306 is not recommended.

Our recommendation is to remove building 306 from the Lodging inventory, allowing the installation to determine an alternate use for this facility. This facility will be removed from the Camp Parks Wellness Solution and Lodging Master Plan.

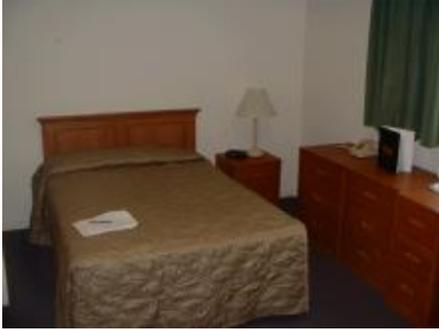
Building 306
Typical Guest Room

- Analysis: Guest Rooms: The hard goods, installed in the early 1990s, consist of a headboard, night stand, dresser, desk with chair, and TV cabinet. The soft goods, also installed in the early 1990s, consist of drapes, TV, mattress and box springs and bed coverings. The Day Rooms have a sofa, love seat, easy chair plus wood tables and chairs. All are in fair condition.
- Recommendation: Replace all hard and soft goods in guest rooms and day rooms.

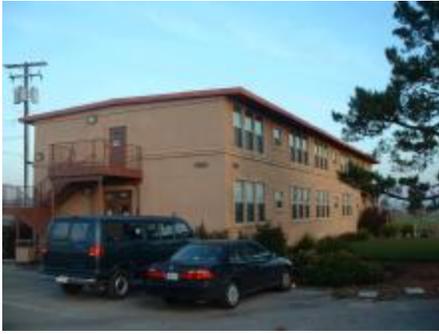
*Building 1150
1150 12th Street
Parks RFTA
Dublin, California*

• Condition Assessment & Upgrade Cost	\$477,172
• Replacement Cost	\$2,069,035
• Condition Assessment & Upgrade to Replacement	23.06%
Cost Ratio

Because the Sum of the Condition Assessment and Upgrade Costs to Replacement Cost Ratio is less than 50.00%, repair, upgrade, and continued use of Building 1150 is recommended.

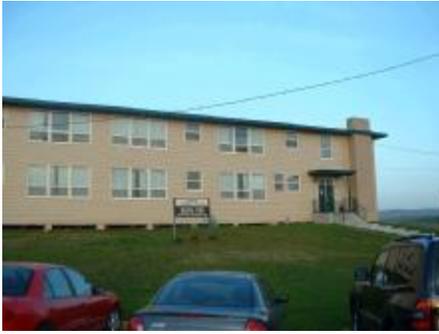
*Building 1151
1151 12th Street
Parks RFTA
Dublin, California*

• Condition Assessment Cost	\$3,050,846
• Replacement Cost	\$5,009,396
• Condition Assessment to Replacement Cost Ratio	60.90%

Because the Condition Assessment to Replacement Cost Ratio is greater than 50.00%, repair of Building 1151 is not recommended.

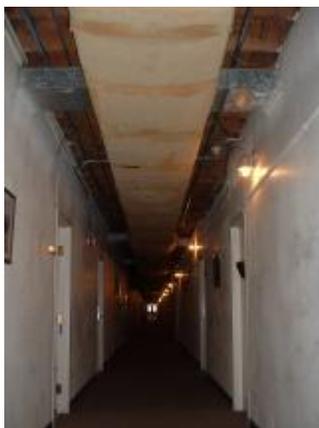
Building 1151
1st Floor Corridor
Exposed Duct, No Ceiling
