# Army Lodging Wellness Recommendation

Fort Carson

August 12, 2003

**3D/I**

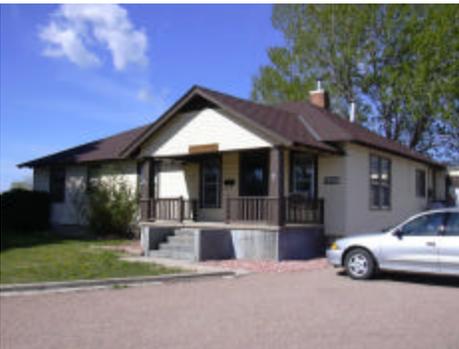
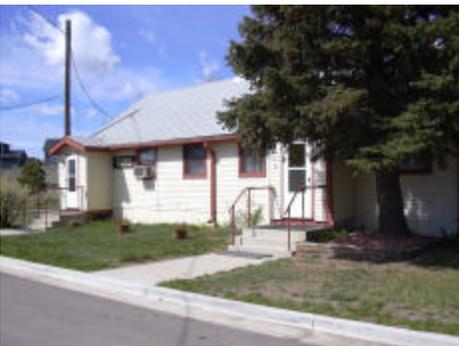
### ***Lodging Building T-6215***

Building T-6215, the Scrub Oak Lodge, constructed in the 1940's, contains 3 suites. This facility currently exceeds Army Lodging size requirements. Converting Scrub Oak Lodge to meet the current standards will require significant construction and will exceed the 50% replacement cost.

Our recommendation is to remove building T-6215 from the Lodging inventory, allowing the installation to determine an alternate use for the facility. Scrub Oak Lodge will be removed from the Fort Carson Wellness Solution and Lodging Master Plan.

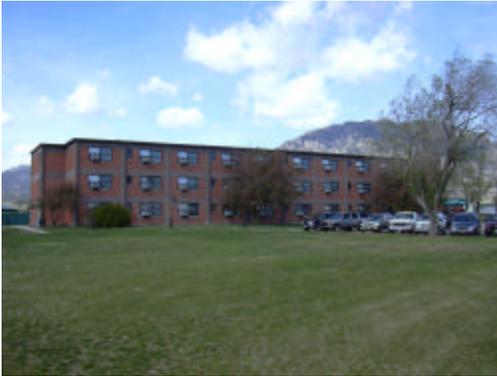
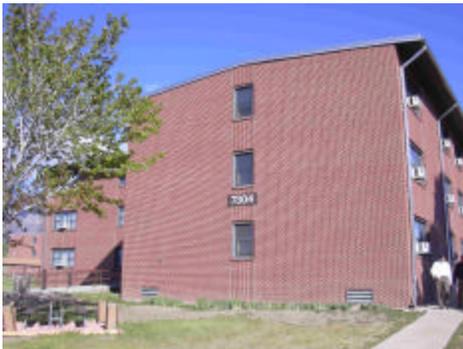
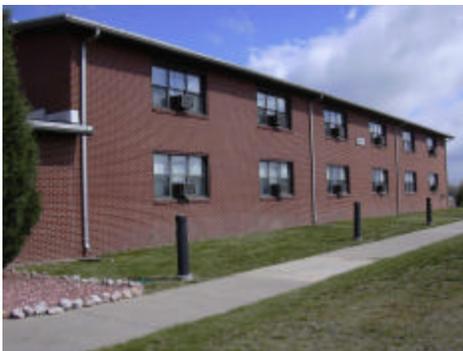
Building 7305, Aspen Lodge, constructed in 1970, currently houses 8 DVQ suites. Four of these are 1-bedroom suites and four are 2-bedroom suites. As indicated in the Facility Assessment, the building's structure and systems are in fair condition; however, converting these rooms to current Army Lodging standards will exceed the 50% replacement cost.

Our recommendation is to remove building 7305 from the Lodging inventory, allowing the installation to determine an alternate use for the facility. Aspen Lodge will be removed from the Fort Carson Wellness Solution and Lodging Master Plan.
