Army Lodging Wellness Recommendation

Fort Leavenworth - Final Submittal

July 25, 2003

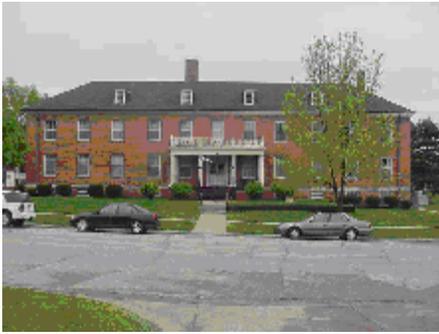
Building 22
327 Pope
Ft. Leavenworth, KS

Building 22, constructed in 1934, is a historical structure and is divided into 9 DVQ rooms. This facility has two stories plus a basement. Each suite/room ranges from 328 to 504 square feet each. This building was renovated in 1986 and had its roof replaced in 2002. The building is in fair condition but does not comply with Lodging requirements. The cost to make improvements and bring it up to Army Lodging standards will exceed the 50% replacement cost.

Our recommendation is to remove this building from the Lodging inventory, allowing the installation to determine an alternate use for this facility. This facility will be removed from the Fort Leavenworth Wellness Solution and Lodging Master Plan.

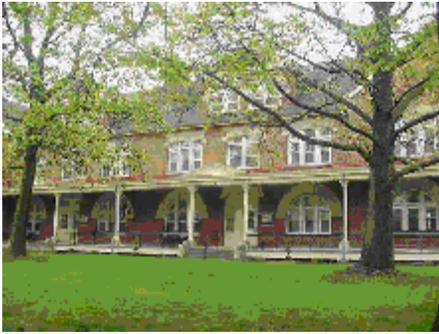
*Building 43
726-633 McClellan
Ft. Leavenworth, KS*

Building 43, constructed in 1892, is a historic structure that is divided into 23 suites. This facility has three stories plus a basement. Each suite has 597 square feet, consisting of a living room, bedroom, and full bath. In 1989, the windows were replaced, the electrical system upgraded, and the structure reinforced. The building is in fair condition but does not comply with Lodging standards. The cost to make improvements and bring it up to Army Lodging standards will exceed the 50% replacement cost.

Our recommendation is to remove this building from the Lodging inventory, allowing the installation to determine an alternate use for this facility. This facility will be removed from the Fort Leavenworth Wellness Solution and Lodging master plan.

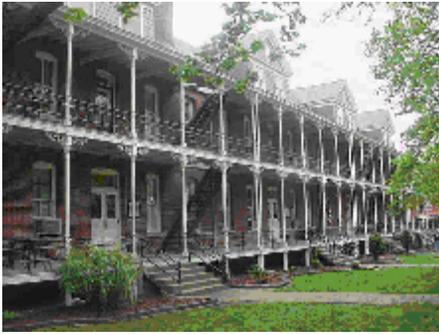
*Building 197
626-632 McCellan
Ft. Leavenworth, KS*

Building 197, constructed in 1901, is a historic structure that has 15 family suites. The facility is a three story building plus basement, with rooms consisting of 504 square feet, each with a living room, bedroom, and full bath. In 1989, the electrical system was upgraded, and the plumbing was renovated throughout the facility. The building is in fair condition but does not comply with Lodging standards. The cost to make improvements and bring it up to Army Lodging standards will exceed the 50% replacement cost.

Our recommendation is to remove this building from the Lodging inventory, allowing the installation to determine an alternate use for this facility. This facility will be removed from the Fort Leavenworth Wellness Solution and Lodging master plan.

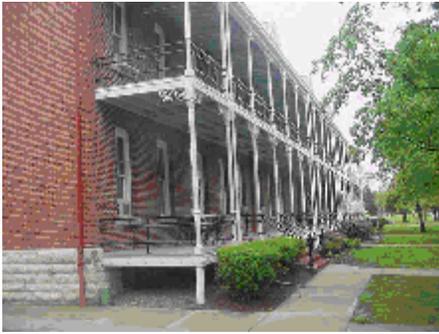
*Building 213
415-21 Kearney
Ft. Leavenworth, KS*

Building 213, constructed in 1903, is a historic structure that has 8 family suites at 615 square feet and 8 DVQ rooms at 1,142 square feet. The facility is three stories plus a basement. Each DVQ has a living room, bedroom, kitchen, and full bath. In 1987, a complete renovation was accomplished, with the exception of the addition of central air conditioning. The building is in fair condition but does not comply with

Lodging standards. The cost to make improvements and bring it up to Army Lodging standards will exceed the 50% replacement cost.

Our recommendation is to remove this building from the Lodging inventory, allowing the installation to determine an alternate use for this facility. This facility will be removed from the Fort Leavenworth Wellness Solution and Lodging master plan.
