# Army Lodging Wellness Recommendation

## Fort Meade - Final Submittal

July 25, 2003

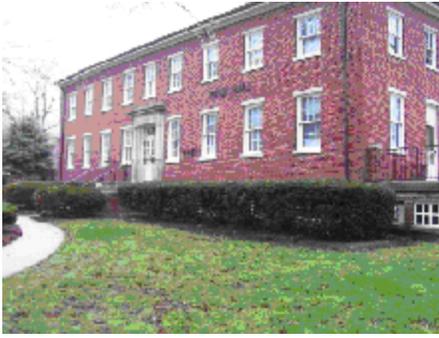
Building 4415  
4415 Llewellyn Drive

Building 4415, Kuhn Hall, constructed in 1944, is a two-story facility housing seven DVQ suites. **The was in poor condition.**  
**The cost to make condition assessment improvements will exceed 50% replacement cost.**

Our recommendation is to remove building 4715 from the Lodging inventory, allowing the installation to determine an alternate use for this facility. This facility will be removed from the Fort Meade Wellness Solution and Lodging master plan.

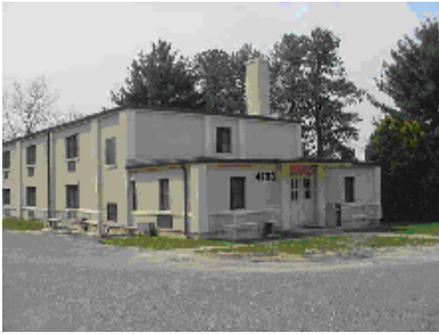
*Building 4703  
4703 Ruffner Road*

Building 4703, Norton Hall, constructed in the late 1930's is a two-story facility housing 14 two-bedroom guest rooms with shared bath rooms, and two one-bedroom guest rooms with shared bath rooms. This facility is in **poor** condition, but does not meet current Army Lodging standards. **The cost to make condition assessment improvements will exceed 50% replacement cost.**

Our recommendation is to remove building 4703 from the Lodging inventory, allowing the installation to determine an alternate use for this facility. This facility will be removed from the Fort Meade Wellness Solution and Lodging master plan.

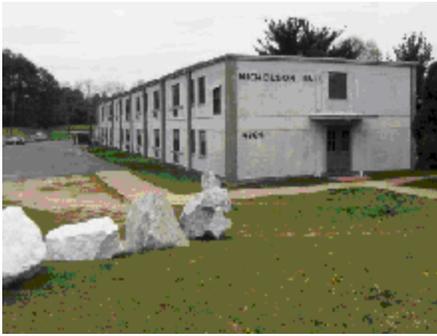
Building 4704  
4704 Ruffner Road

Building 4704, Nicholson Hall, constructed in the late 1930's is a two-story facility housing 30 one-bedroom guest rooms with shared bath rooms. This facility is in **poor** condition, but does not meet current Army Lodging standards. **The cost to make condition assessment improvements will exceed 50% replacement cost.**
