# Army Lodging Wellness Recommendation

Fort Sill - Final Submittal

August 18, 2003

**3D/I**

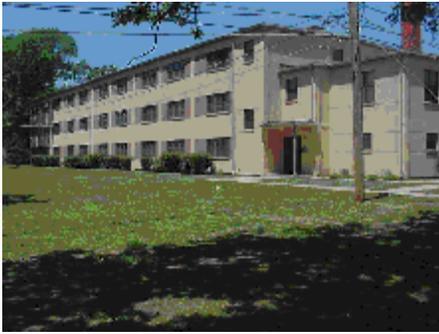
Building 850, Condon Road, Ft. Sill, OK

Buildings 850, 851, 852, 853, and 854, are 2-story structures, similar in construction and age. Building 850, built in 1956, is divided into 30 family suites at 434 square feet, and one DVQ suite at 890 square feet. Building 851, constructed in 1963, houses 16 family suites at 600 square feet each. Building 852 and 854, constructed in 1963, each house 14 family suites at 600 square feet each. Building 853, constructed in 1963, has 14 family suites at 625 square feet each. These buildings are in fair condition, but do not meet current Army Lodging standards. The cost to make improvements and to bring these facilities up to Army Lodging standards will exceed the 50% replacement cost.

Our recommendation is to remove these buildings from the Lodging inventory, allowing the installation to determine alternate uses for these facilities. These facilities will be removed from the Fort Sill Wellness Solution and Lodging Master Plan.
