Army Lodging Wellness Recommendation

Fort Tripler/Shafter - Final Submittal

August 22, 2003

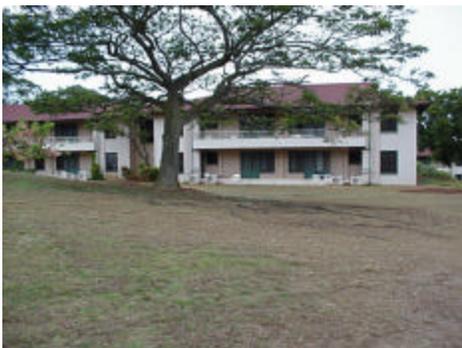
Building 226E, constructed in 1946 as nurse quarters, is a 2-story historic structure housing 15 multi-room suites. Although this facility was renovated, it does not meet Lodging standards and cannot be reconfigured without significant reconstruction. To make condition assessment improvements to Building 226E will exceed the 50% replacement cost.

Our recommendation is to remove building 226E from the Lodging inventory, allowing the installation to determine an alternate use for this

facility. This facility will be removed from the Fort Tripler/Shafter Wellness Solution and Lodging Master Plan.
