# Army Lodging Wellness Recommendation

## Aberdeen Proving Ground - Pilot

August 22, 2003

# Aberdeen Proving Ground

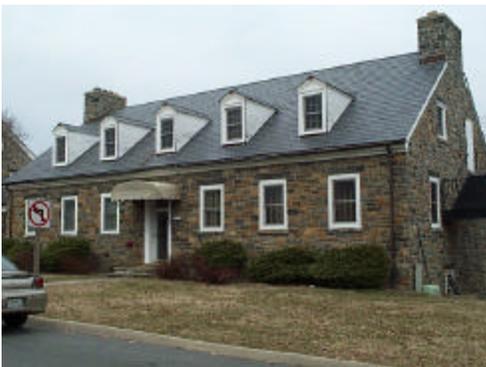
### ***Lodging Building 30***

Building 30, constructed in 1936, is a historical structure and is divided into two separate Lodging facilities, each housing 3 family suites. The facility is collocated with the Officer's Club, connected by breezeways on either side of the club facility. Although these facilities were renovated within the last 5 years, they do not meet Lodging standards and cannot be reconfigured without significant reconstruction. To renovate Building 30 to the new standards and configuration will exceed the 50% replacement cost.

Our recommendation is to remove building 30 from the Lodging inventory, allowing the installation to determine an alternate use for the facility. This facility will be removed from the Aberdeen Wellness Solution and Lodging Master Plan.

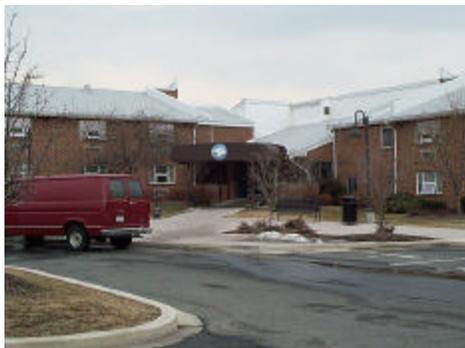
Building 2207, constructed in 1977, received a major renovation in 1999. The building has 149 existing extended stay rooms. The building is in good condition and meets a majority of the Army functional standards from the perspective of the guest room requirements.

The building infrastructure is to be used over the next 15-20 years with normal maintenance. Based on age of the structure, however, we do not recommend significant renovations to the public spaces and/or back-of-

the-house space to meet functional criteria. These existing support spaces will be reconfigured to meet other functional requirements, with one administrative space built as a guest room to be renovated back to a guest room, for a total of 150 rooms. Support spaces are included in the proposed new Lodging facility design in accordance with the criteria for the total 291 rooms.

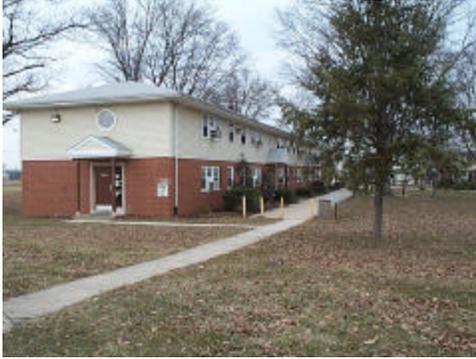
***Lodging Buildings 2208, 2209, 2504, and 2505.***

These four buildings were built in 1959. Building 2208 has 14 Lodging rooms, building 2209 has 20 Lodging rooms, building 2504 has 16 Lodging rooms, and building 2505 has 20 Lodging rooms. Most rooms are 1-3 bedrooms, with shared kitchens, and some with shared baths. They do not meet current Lodging standards. All four of these buildings are in fair condition, but do not meet Army Lodging standards. The cost to make improvements and bring up to Army Lodging standards will exceed the 50% replacement cost.

Our recommendation is to remove these buildings from the Lodging inventory, allowing the installation to determine an alternate use for the facilities. These facilities will be removed from the Aberdeen Wellness Solution and Lodging Master Plan.

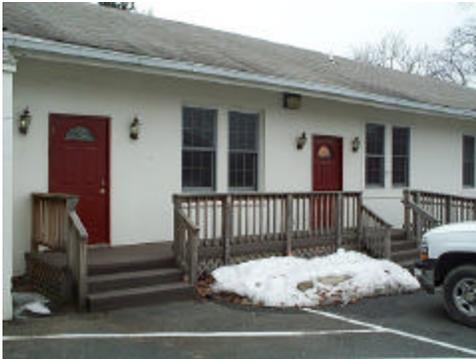
***Lodging Building E4650***

This building, constructed in 1992, has two family rooms as part of another structure. It is located in the Edgewood area, approximately 20 minutes from the Aberdeen Proving Ground main installation. Both rooms are two bedrooms with kitchens.

This building and rooms are in good condition as indicated on the Facility Assessment but do not meet the Lodging size requirements or provide appropriate support spaces. The cost to modify to meet Army Lodging standards will exceed the 50% replacement cost.

Our recommendation is to remove building E4950 from the Lodging inventory, allowing the installation to determine an alternate use for the facility. This facility will be removed from the Aberdeen Wellness Solution and Lodging Master Plan.

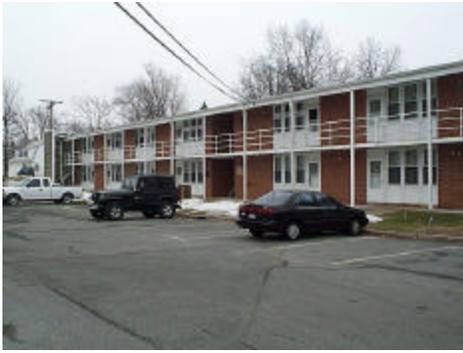
### ***Lodging Buildings E4900 and E4902***

These two buildings, constructed in 1969, are located in the Edgewood area, approximately 20 minutes from the Aberdeen Proving Ground main installation. Building E4900 and E4902 each have a total of 32 Lodging rooms, 28 rooms are single rooms with kitchens, 4 rooms are 1 bedroom with kitchens.

Both of these buildings are in poor condition, but do meet the Lodging size requirements. The cost to make condition assessment improvements, however, will exceed the 50% replacement cost.

Our recommendation is to remove buildings E4900 and E4902 from the Lodging inventory, allowing the installation to determine an alternate use for the facilities. These facilities will be removed from the Aberdeen Wellness Solution and Lodging Master Plan.
