Army Lodging Wellness Recommendation

Final Submittal - Camp Parks

February 27, 2004

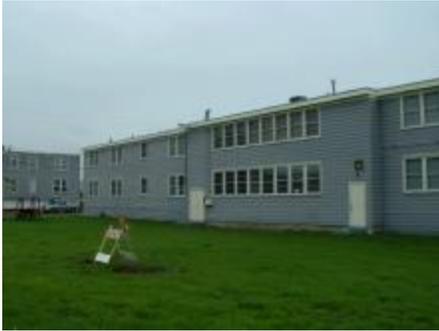
Building 306
Back of Building

• Condition Assessment Cost	\$2,064,887
• Replacement Cost	\$2,107,766
• Condition Assessment to Replacement Cost Ratio	97.97%

Because the Condition Assessment to Replacement Cost Ratio is greater than 50.00%, repair of Building 0306 is not recommended.

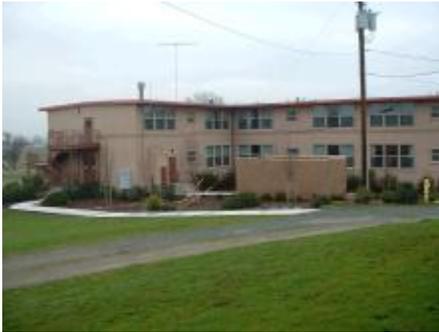
Building 1150
Back of Building

• Condition Assessment & Upgrade Cost	\$477,172
• Replacement Cost	\$2,069,035
• Condition Assessment & Upgrade to Replacement	23.06%
Cost Ratio

Because the Sum of the Condition Assessment and Upgrade Costs to Replacement Cost Ratio is less than 50.00%, repair, upgrade, and continued use of Building 1150 is recommended.

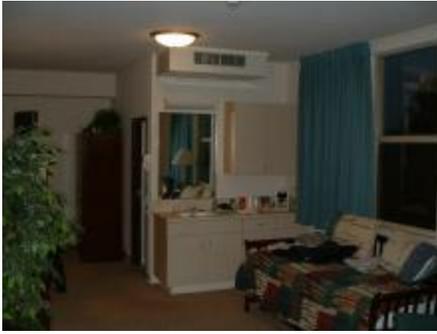
Building 1150
Typical Standard Room

- Analysis: The windows are thermal glazed aluminum frame with powder coat finish, of the latest major renovation, are in like new condition.

- Recommendation: No corrective action required.

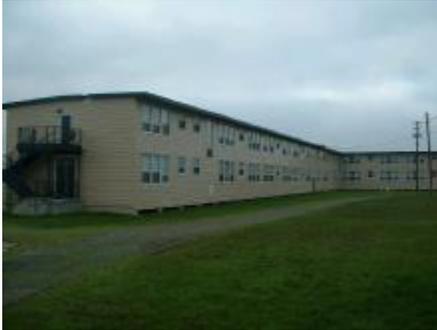
Building 1151
Back of Building

• Condition Assessment Cost	\$3,050,846
• Replacement Cost	\$5,009,396
• Condition Assessment to Replacement Cost Ratio	60.90%

Because the Condition Assessment to Replacement Cost Ratio is greater than 50.00%, repair of Building 1151 is not recommended.
